▶ REPORT INTO A FIRE AT RA WOOD
ADHESIVE TAPES CANNOCK ON 5
NOVEMBER 2009

TS09199-R01-ISSUE 1

for:
Kingspan Ltd
GreenField Business Park No 2
Greenfiled
Holywell
Flintshire
CH8 7HU

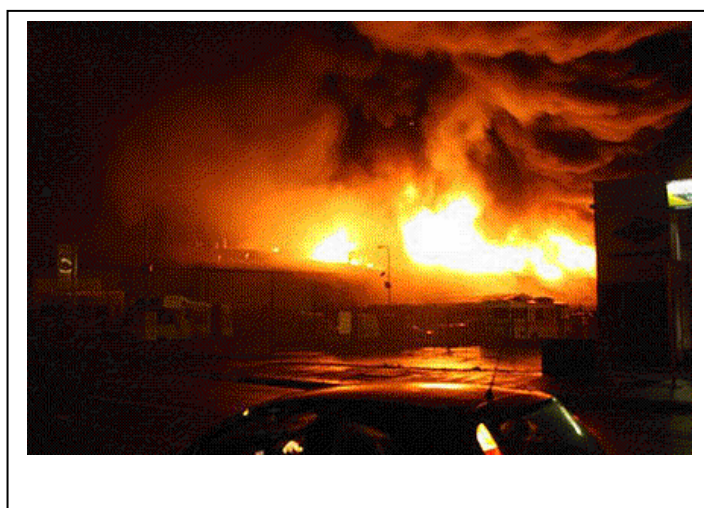
Figure 3- photograph of fire in Express and Star web report

- 3.1 From statements made by I Bullock during the site visit on 16 November, it is understood that the fire started whilst persons were still within the premises in the late evening of 5 November and that suspected ignition event involved a high level light fitting towards the northeast corner of the production area in the RA Wood Adhesives Tapes demise.
- 3.2 We understand that all persons safely evacuated the building without injury.
- 3.3 Press reports posted on the web on 6 November 2009 (Express and Star) reported a very significant fire event requiring attendance by 60 fire service personnel.
- 3.4 Figure 3 (an image provided in the web press report) gives an idea of the intensity of the fire, resulting in penetration of fire through the roof and flaming well above the height of the building.

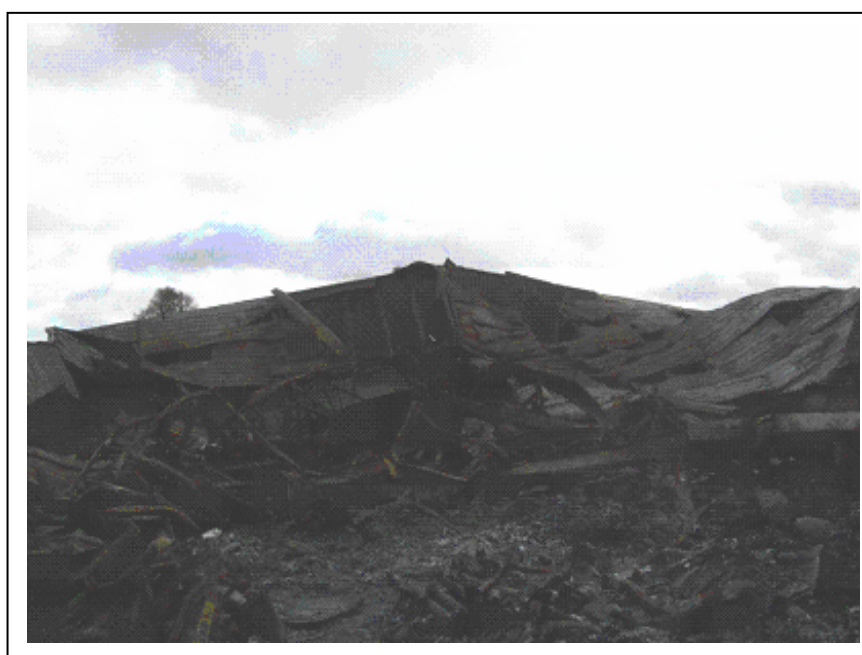
Figure 4 - view from western extremity of the building towards the adjacent demise line

- 4.1 It was clear from the site inspection that the fire load density within the RA Wood Adhesives Building had been significant with the resulting fire being sufficiently intense to result in complete destruction of the covered storage building and the part of the main building occupied by RA Wood Adhesive Tapes.
- 4.2 Figure 4 shows a view from the western most extremity of the building towards the compartment wall (still standing) to the adjacent joinery business demise. The picture illustrates the complete destruction of all roof supporting structure over the production area compartment in the RA Wood Adhesive Tapes demise.

- 4.4 The complete collapse of steel supporting structure shown in Figures 4 and 5, and the presence of melted aluminium from door controls indicates that global temperatures attained in the production area compartment were significantly in excess of 650°C.
- 4.5 The 30 minute fire door and fire rated glazed screen (provided with Georgian Wired Glass) between ground level office accommodation and the production area appeared to have maintained effective separation for a period but eventually lost their integrity.
- 4.6 Figure 6 shows the remnants of the fire resisting glazed screen. The georgian wired glass has fallen from the frame which has been eroded by the fire.

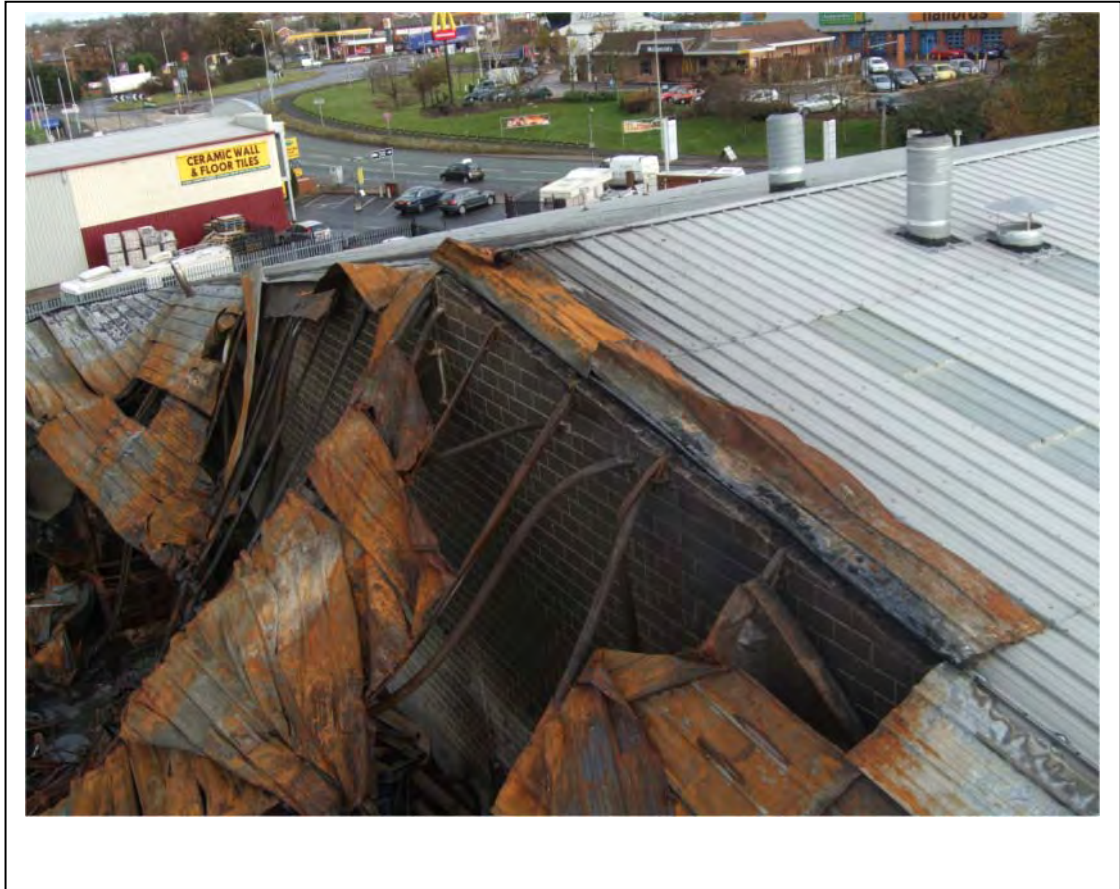
Figure 5 - photograph from high level looking northwards along tenancy separation line

- 4.3 Figure 5 shows a photograph taken from an aerial platform position to the south side of the building and looking along the line of the compartment wall separating the RA Wood Adhesive Tapes demise (to the west) and Joinery company (to the east). The photograph illustrates how the fire has completely destroyed the roof structure to the left whilst the roof over the joinery company demise is still in place.

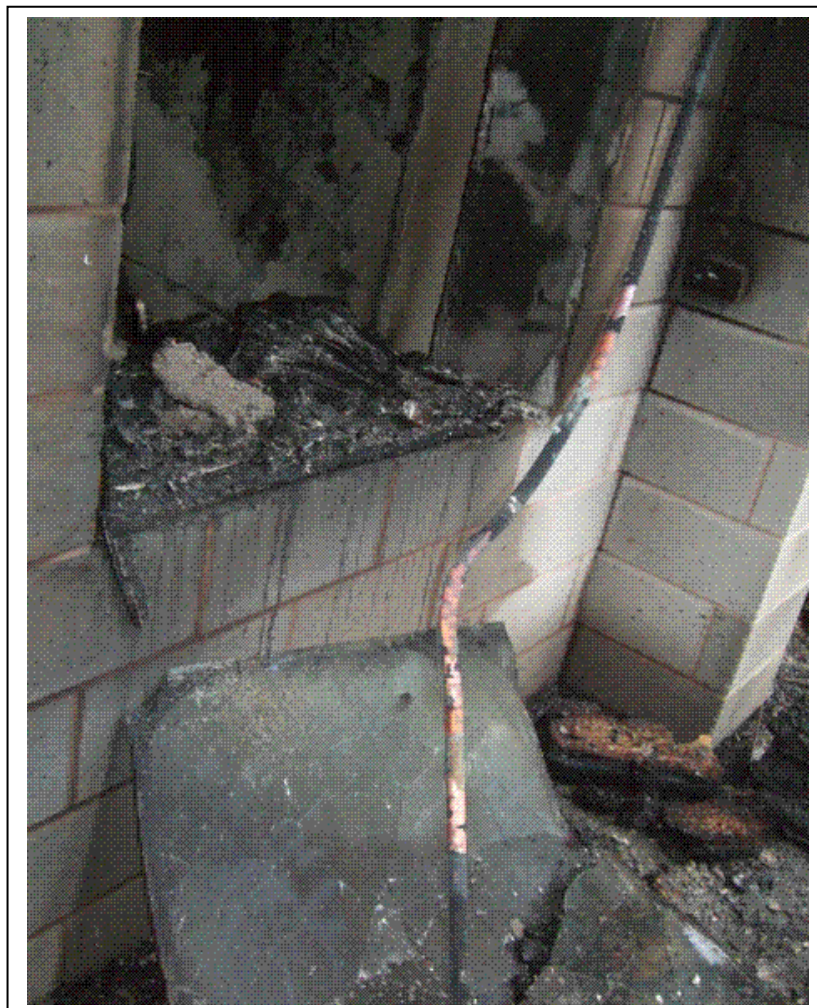
Figure 6 - Effects on fire resisting glazed screen between office and production area

- 4.7 The evidence illustrated in these photographs indicates that the severity of the fire was substantially in excess of that to which 30 minute fire resisting elements of construction would be subjected under standard fire resistance testing procedures to BS476 or BSEN1363.

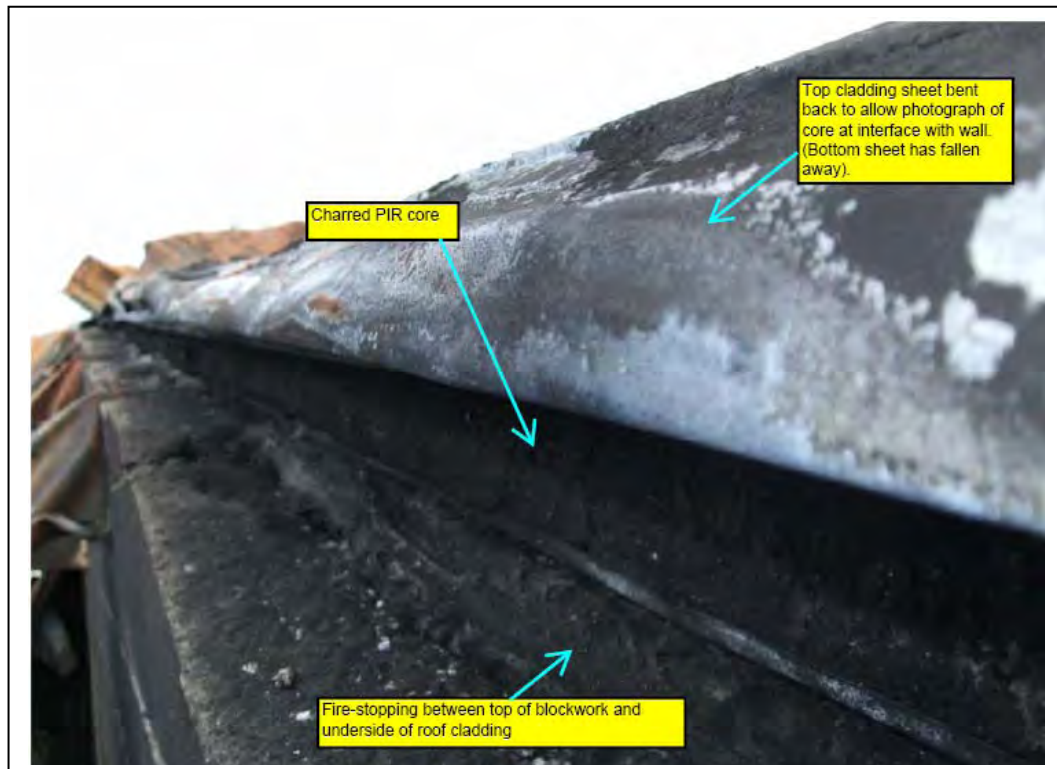
Figure 7 - photograph of head of party wall between tenancies

- 4.10 Figure 7 shows a photograph taken along the head of the blockwork party wall between the tenancies and shows a close-up of the charred PIR core of the roof cladding. The PIR core remained in place to the centre of the blockwork leaf on the RA Wood Adhesive Tapes side of the party wall.

- The fire compartmentation provided by the party wall prevented fire spread from the demise of origin to the adjacent demise.
- The charring exhibited by the PIR core material indicated the formation of a sufficiently stable char within the panel to provide an effective fire stop between the steel skins of the cladding at the head of the compartment party wall.

- The omission of a band of material of limited combustibility in the composite roof panel at the point of intersection with the head of the party wall (as recommended by Approved Document B guidance) did not result in a break-down of fire compartmentation.

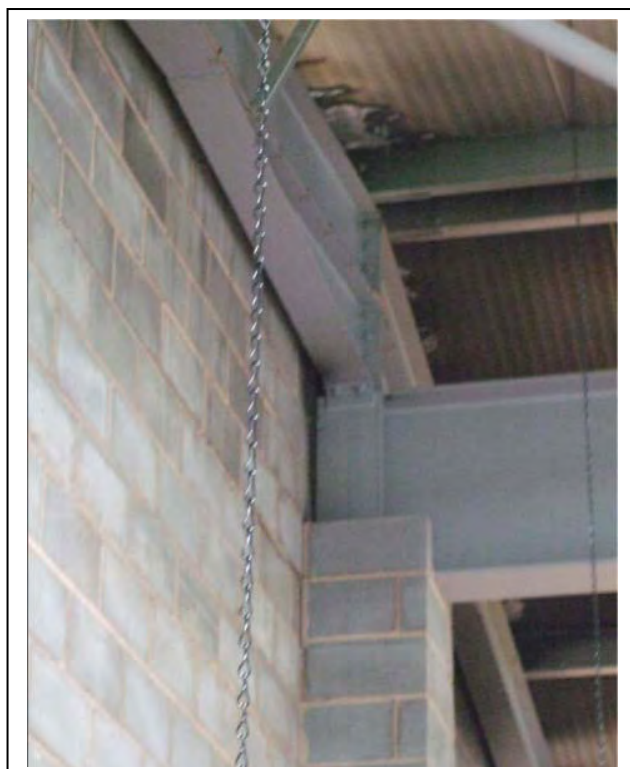
Figure 8 - photograph of underside of roof in Joinery Company demise

4.11 Figure 8 shows a photograph taken from inside the adjacent joinery company demise looking up at the underside of the roof cladding along the party wall line.

- 4.12 It is understood from talking to staff in the joinery company that there was smoke leakage into their demise and this was also evidenced by the striations of smoke staining on the roof soffit and local loss of the PVC coating to the steel skin close to the apex. However, it was clear from the inspection that there was no loss of fire compartmentation provided by the party wall and the fire did not spread to the adjacent demise.
- 4.13 The roof cladding over the joinery company demise remained sufficiently intact to provide continued weather protection to the demise and to allow that business to resume operations shortly after the fire was extinguished by the fire service.
