▶ REPORT INTO A FIRE AT RA WOOD
ADHESIVE TAPES CANNOCK ON 5
NOVEMBER 2009

TS09199-R01-ISSUE 1

for:
Kingspan Ltd
GreenField Business Park No 2
Greenfiled
Holywell
Flintshire
CH8 7HU

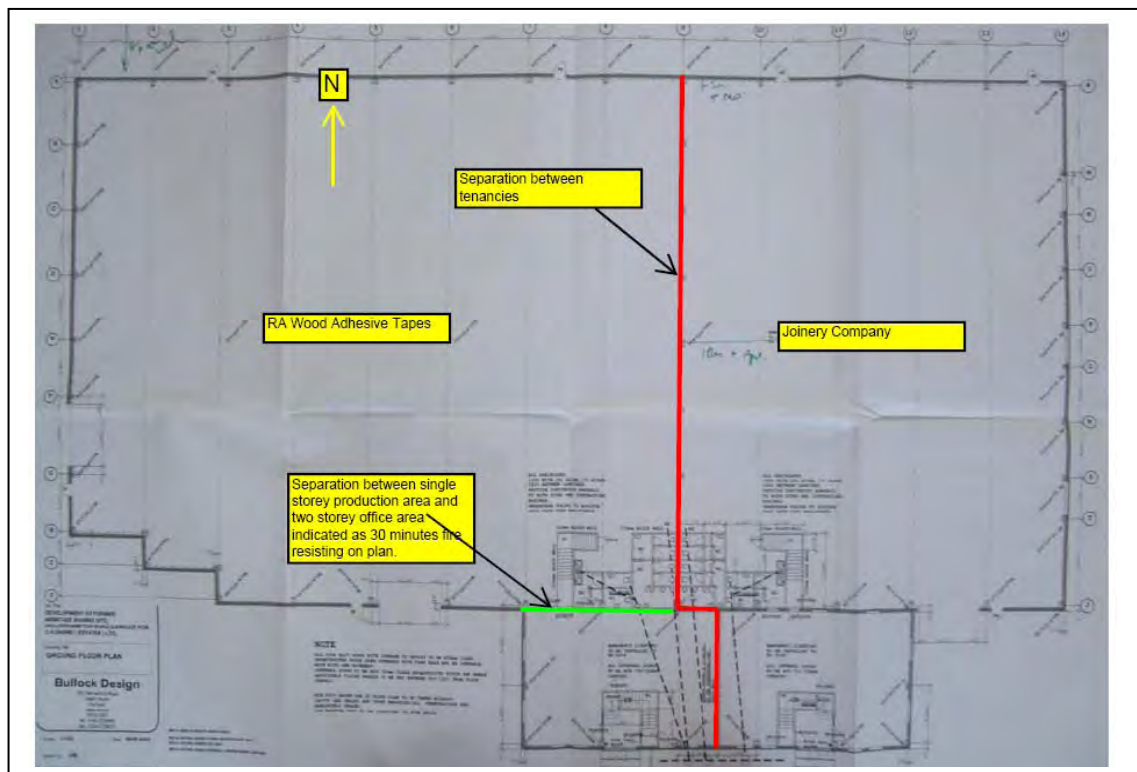
Figure 1 - Plan drawing of building

- 2.1 The building is located on the Wedges Mills industrial estate in Cannock, Staffordshire. It is understood that the building was constructed in 2003.
- 2.2 On plan the building measures approximately 78m (from west to east) by 46m (from north to south) with a height to eaves of approximately 6.5m and height to roof apex of approximately 10m.
- 2.3 The building is occupied by two tenants, RA Wood Adhesive Tapes (to the west) and a joinery Company (to the east). An imperforate full height blockwork wall in the plane of the main portal frame structure separates both tenancies. The area occupied by RA Wood Adhesives Tapes measures approximately 1840m² in plan.
- 2.4 Figure 1 shows a plan of the building (this is a photograph of an A1 drawing as an electronic drawing file was not available).

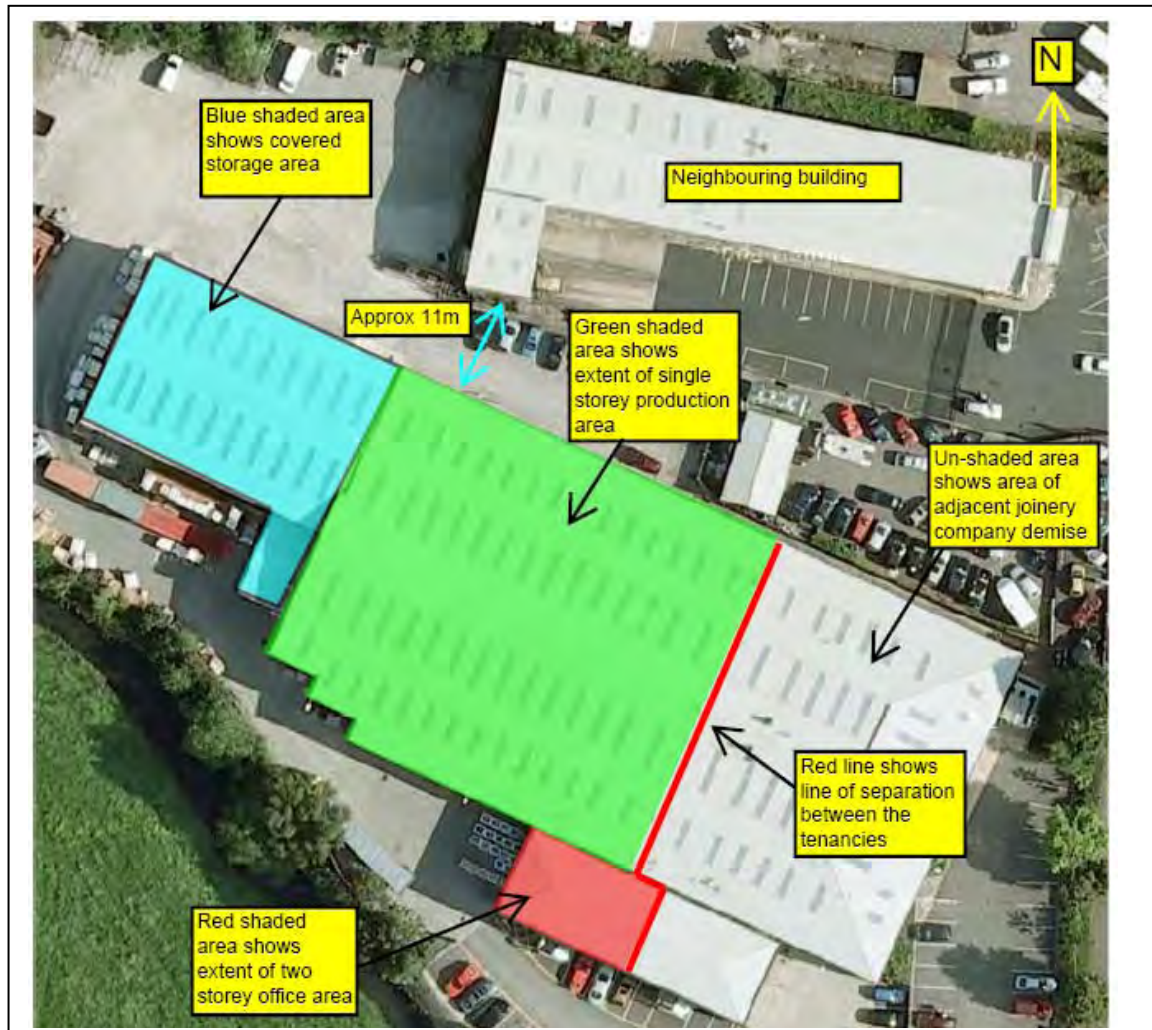
Figure 2 - Aerial view of site before fire

2.8 Figure 2 shows an aerial view of the site taken from Google Maps. The image has been marked up to indicate the location of the covered storage area and the wall dividing the two tenancies.
